December 24, 2018
Kleinfelder Project No.: 20190476.001A

**SUBJECT: 2018 ANNUAL REPORT
OF SEMI-ANNUAL BARRIER MAINTENANCE AND MONITORING
MURRAY COSTCO WHOLESALE WAREHOUSE #764
5201 SOUTH INTERMOUNTAIN DRIVE
MURRAY, UTAH**

SITE BARRIER PLAN

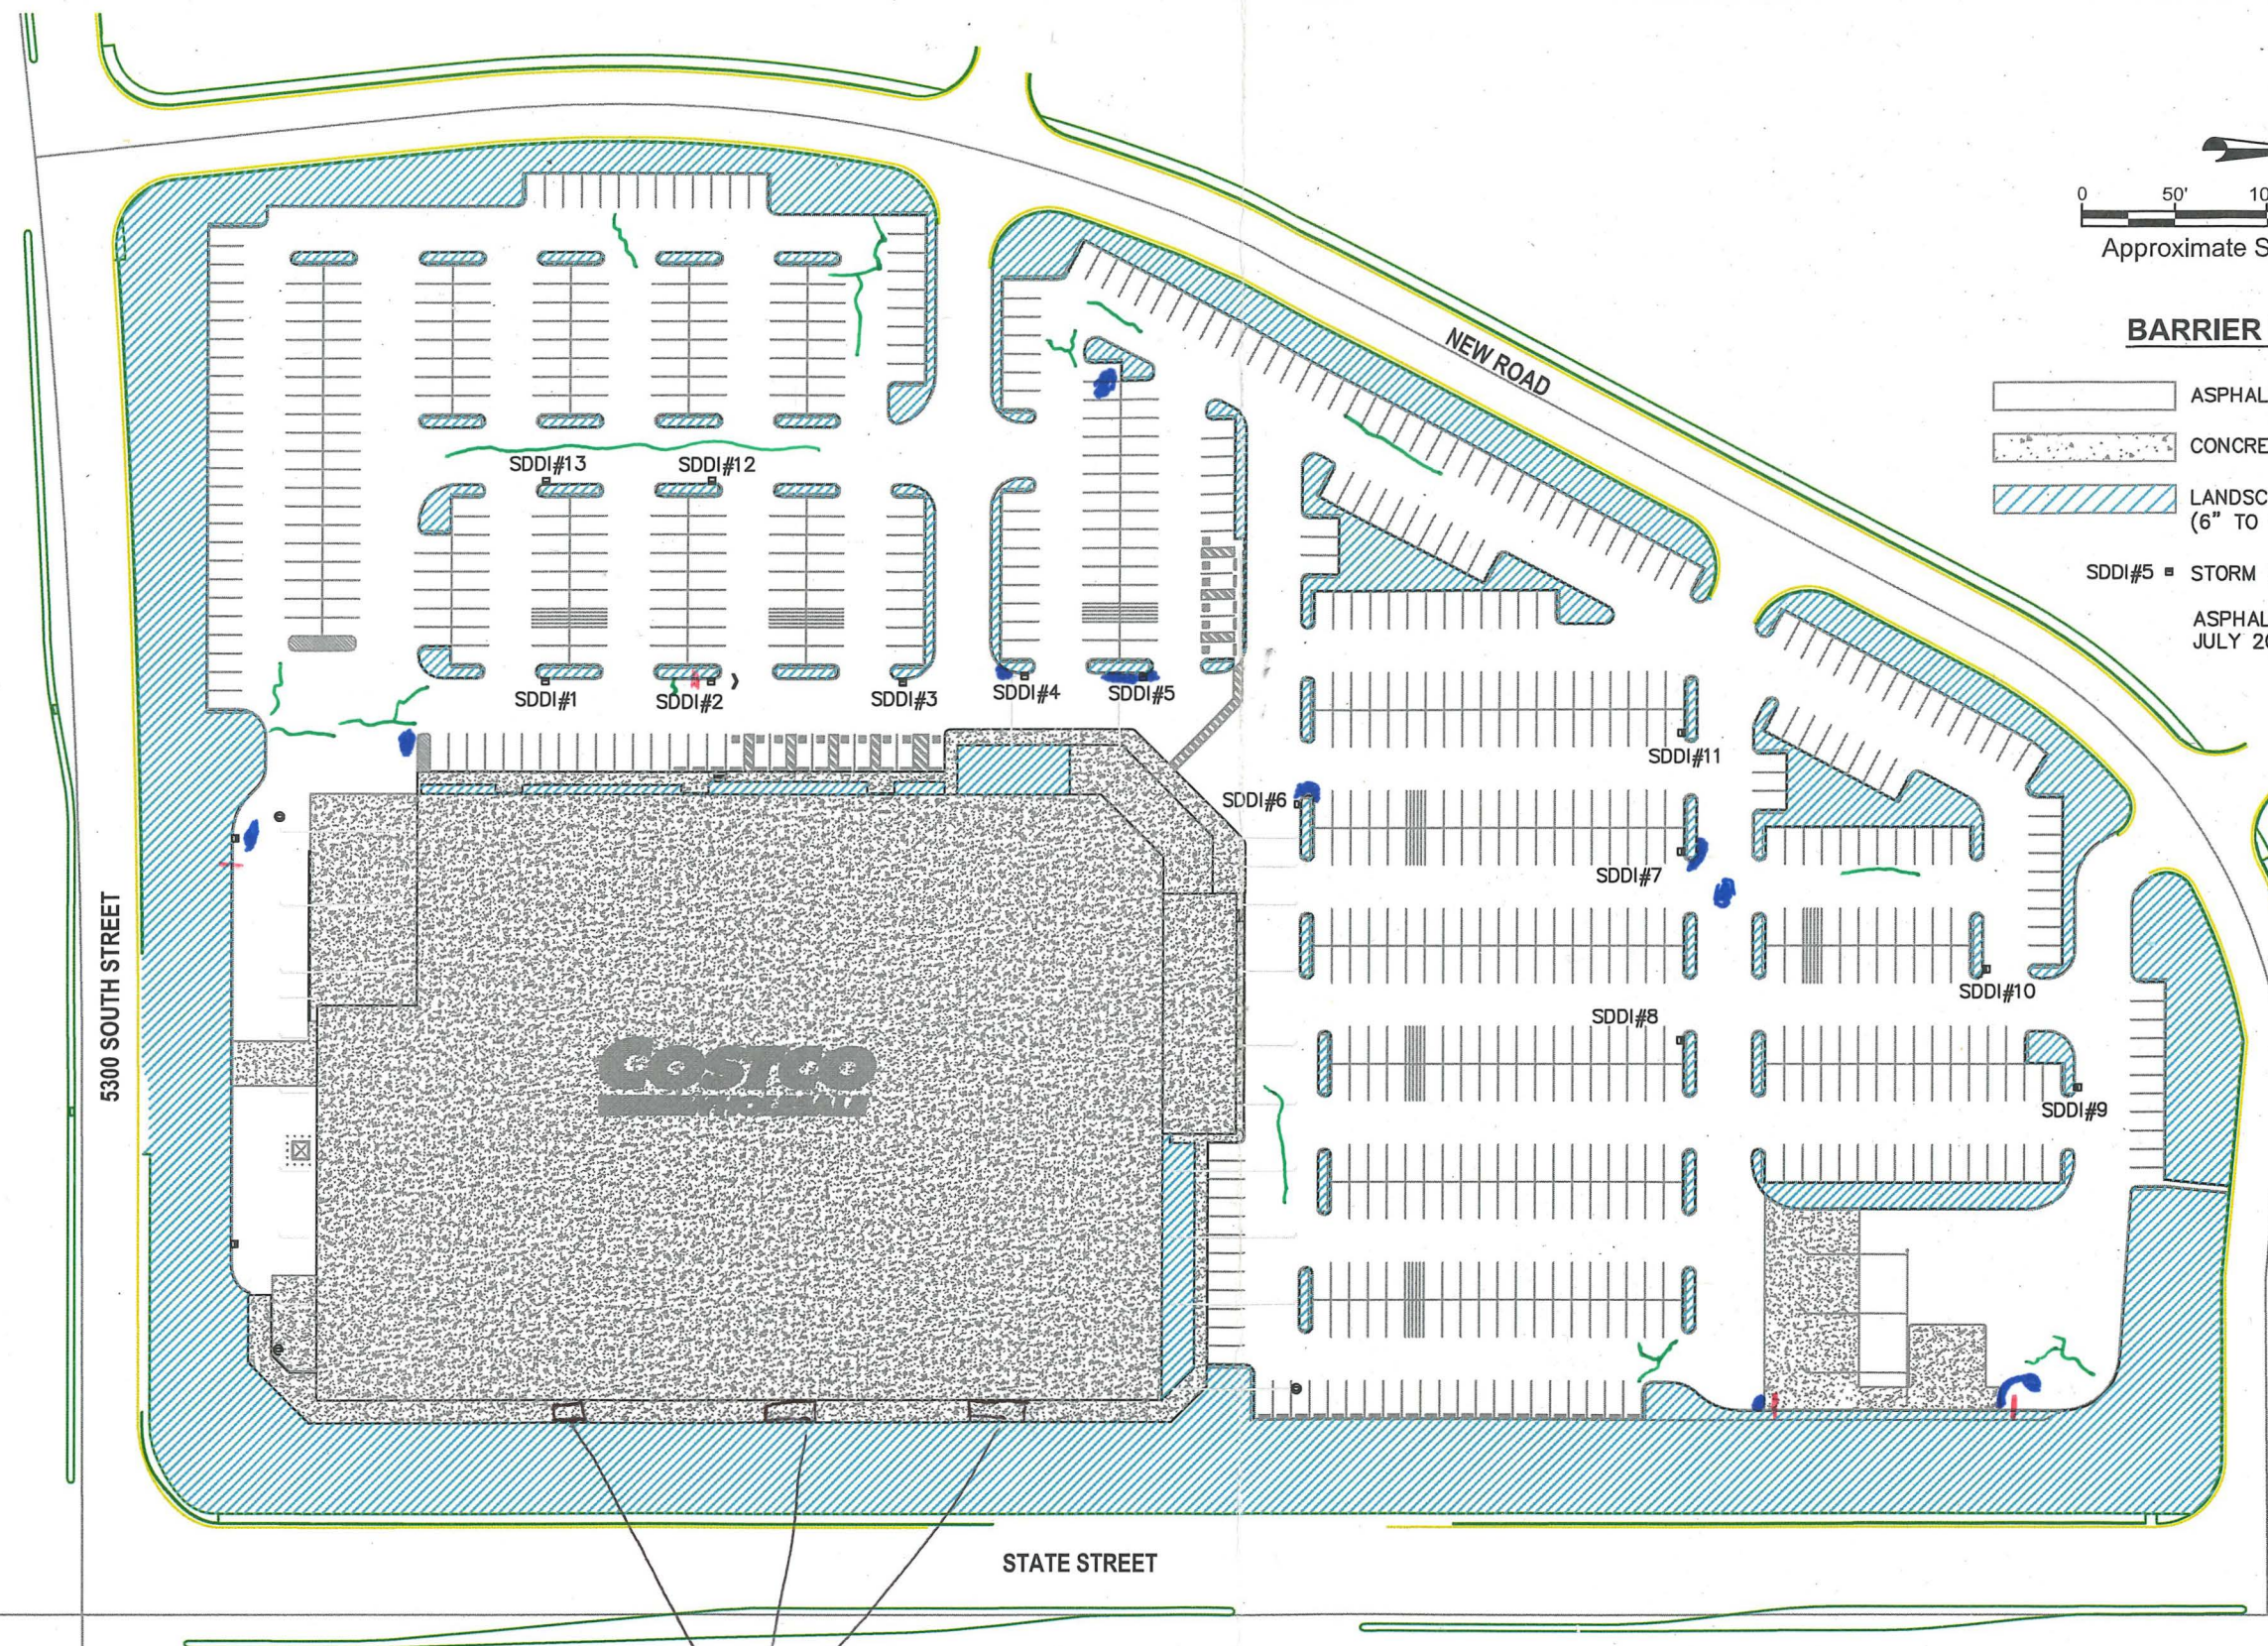
FIGURE

ASPHALT PAVEMENT REPAIR COMPLETED IN JULY 2003

- CONCRETE DAMAGE
- SETTLING
- CRACKED SEALANT OR PAVEMENT
